Long-term Performance of Engineered Barrier Systems PEBS

Engineered Barrier Emplacement Experiment in Opalinus Clay: “EB” Experiment

AS-BUILT OF DISMANTLING OPERATION

(DELIVERABLE-Nº: D2.1-4)

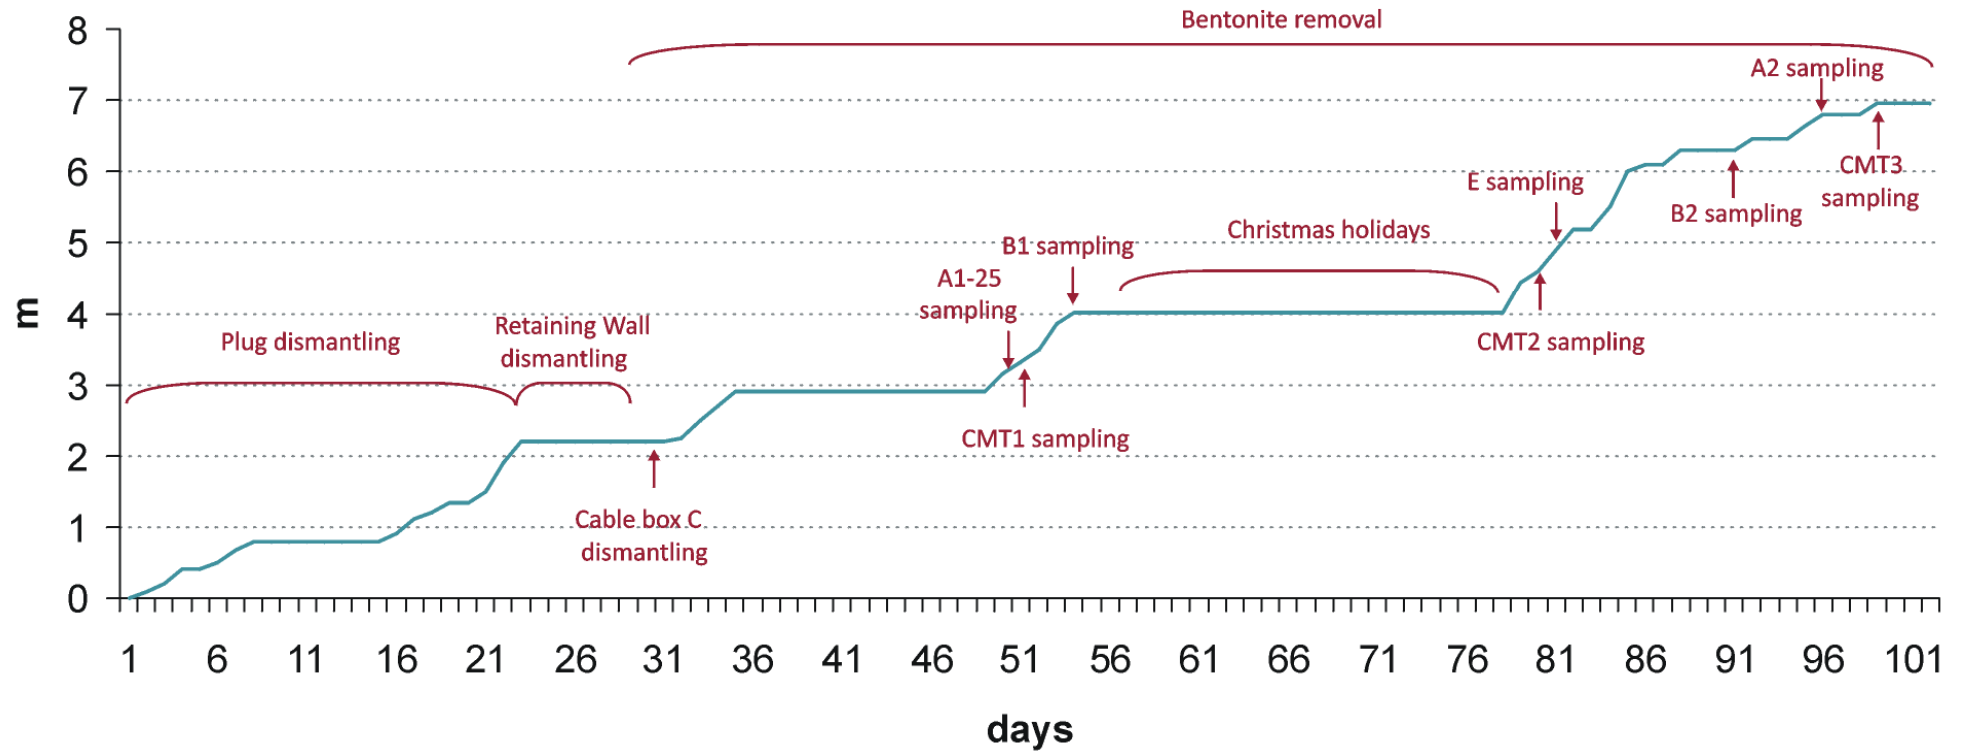
Figure 2: Evolution of the EB experiment. Duration in days of the whole operation (x axis) vs. progress in depth in the gallery (y axis)

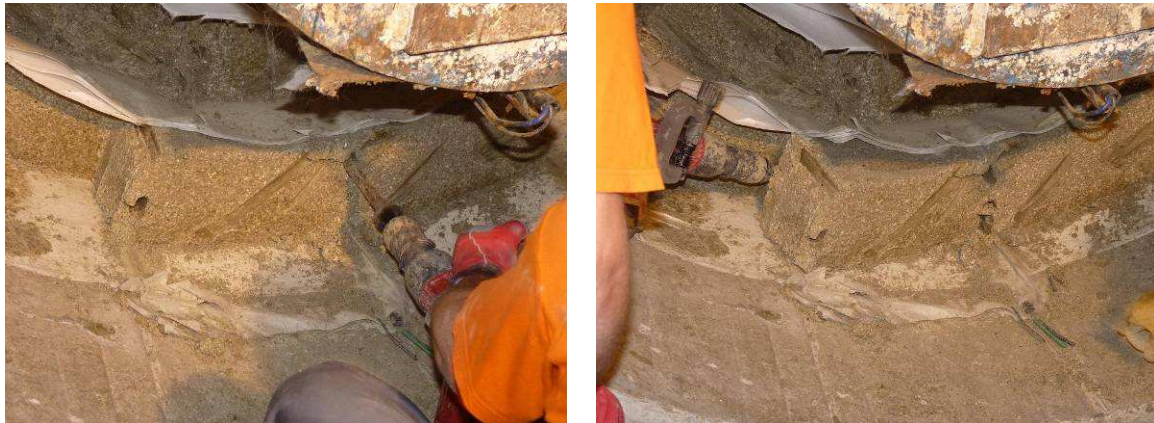
For the removal of the bentonite blocks, the percussion hammer was provided with a pointy bit in order to separate the blocks between them and remove them in one whole piece. See Figure 20.

Figure 20: Tools for bentonite blocks removal

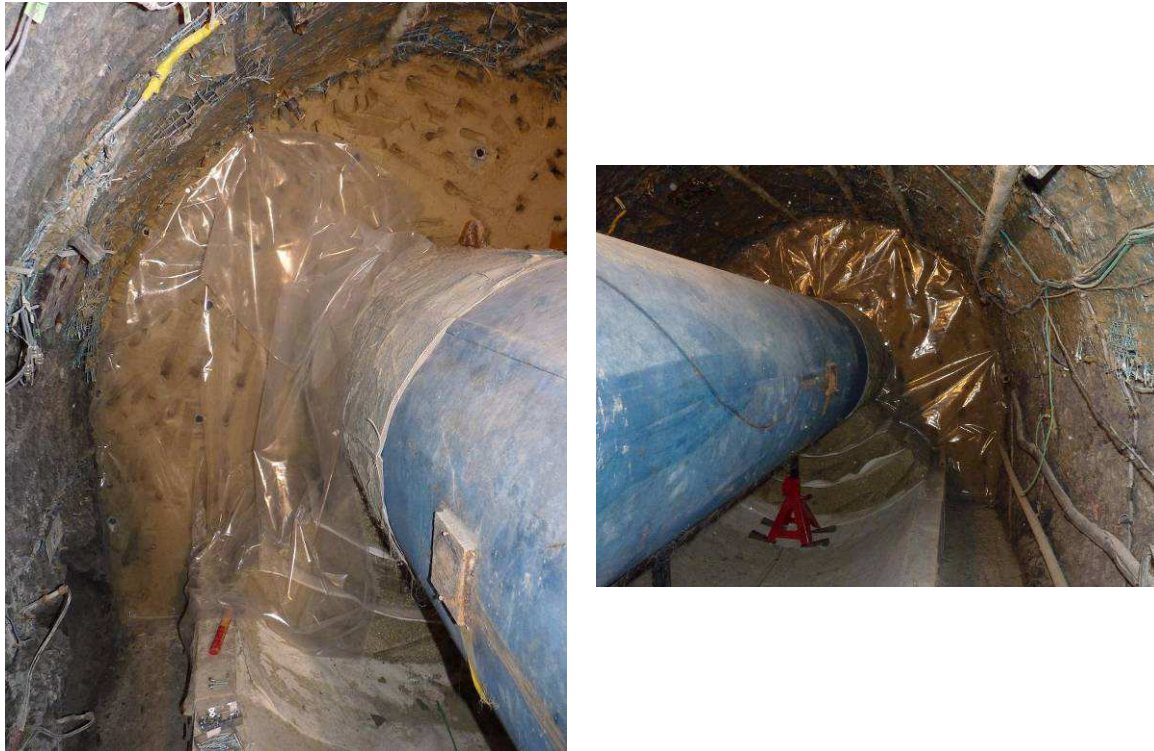
At the end, the front of the left bentonite was covered with a plastic in order to keep the humidity until the demonstrator was built. See Figure 26.

Figure 26: Front of the remaining bentonite covered with plastic

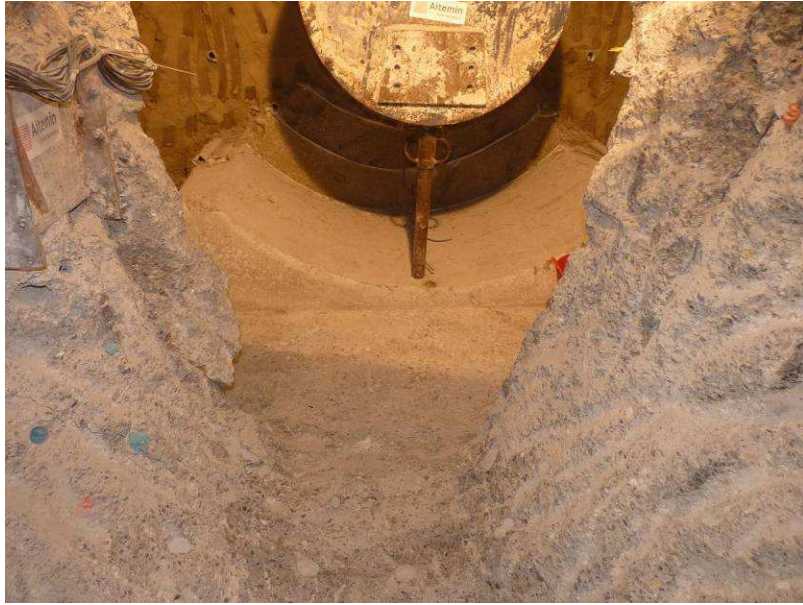
Figure 27: Metallic extensible support for canister

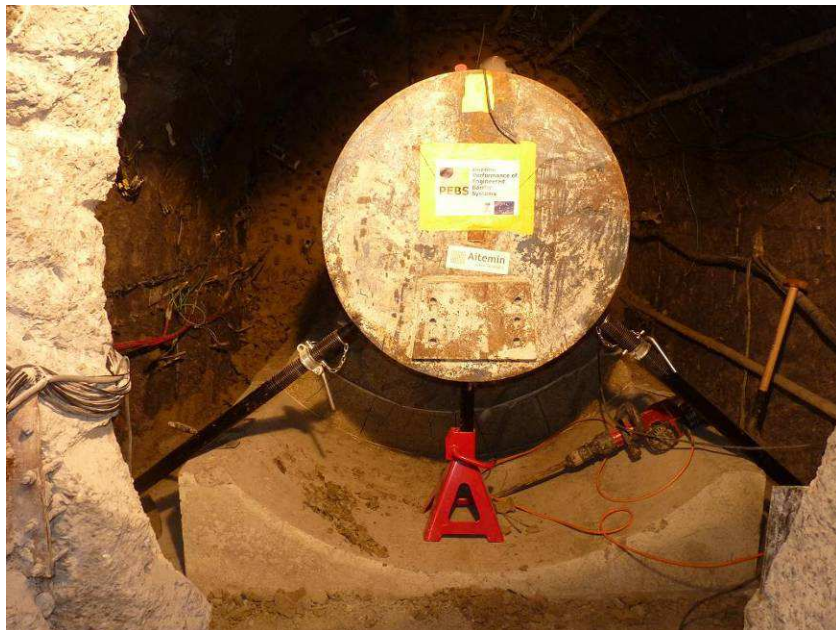
As the length of the uncovered canister increased, the metallic support was replaced by a metallic sawhorse able to support up to 10 t, and it was reinforced by two metallic extensible supports holding the left and right sides of the canister. See Figure 28.

Figure 28: Sawhorse support for canister

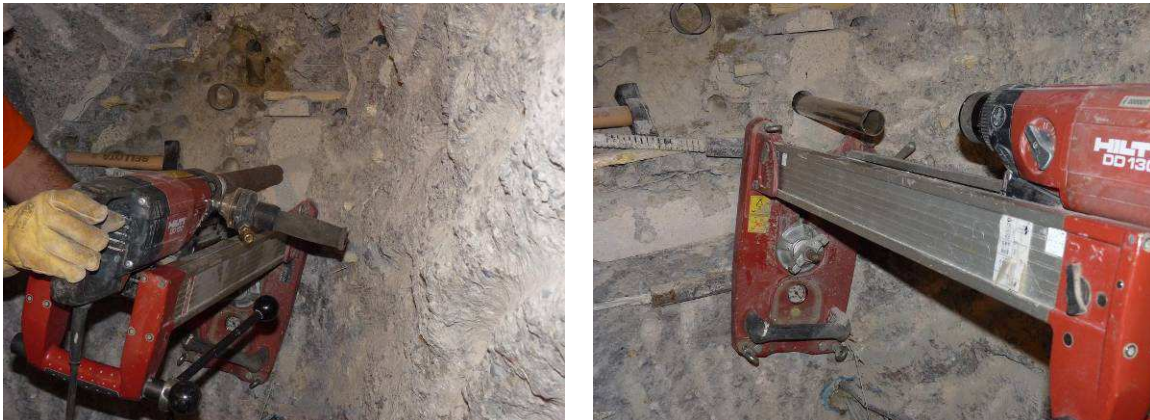
The first samples were taken by means of rotating coring equipment for the concrete part and then a stainless steel pipe used in the bentonite part. See Figure 36.

Use of the rotating coring equipment for the concrete part

Use of a stainless steel pipe for the bentonite part

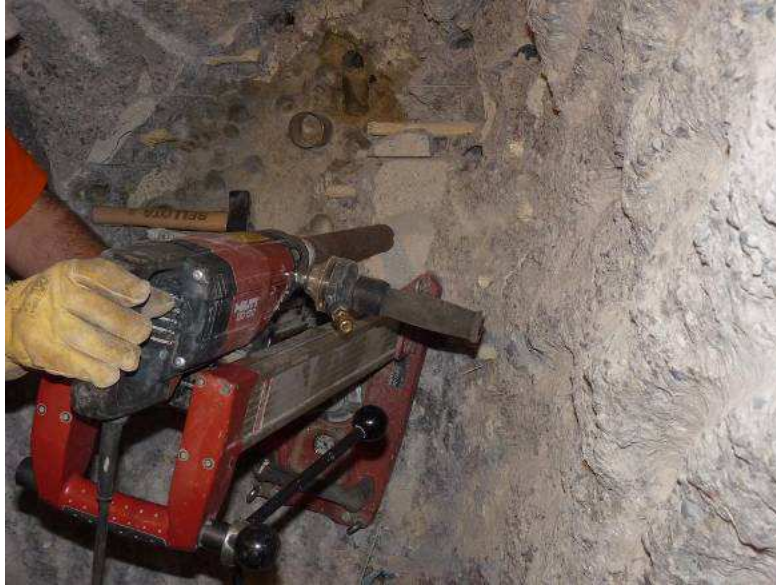
Samples of the OPA/Bentonite interface were taken along the dismantling operation as requested by the organizations. For the bentonite, a stainless steel pipe was used to sample up to the OPA by pushing the pipe against the bentonite. Then the rotating coring device adapted with a crown of the same diameter than the stainless steel pipe was used to sample the OPA part (See Figure 38). Then each sample was packed as a whole one keeping the interface between the two materials in contact.

Figure 38: OPA/Bentonite sampling

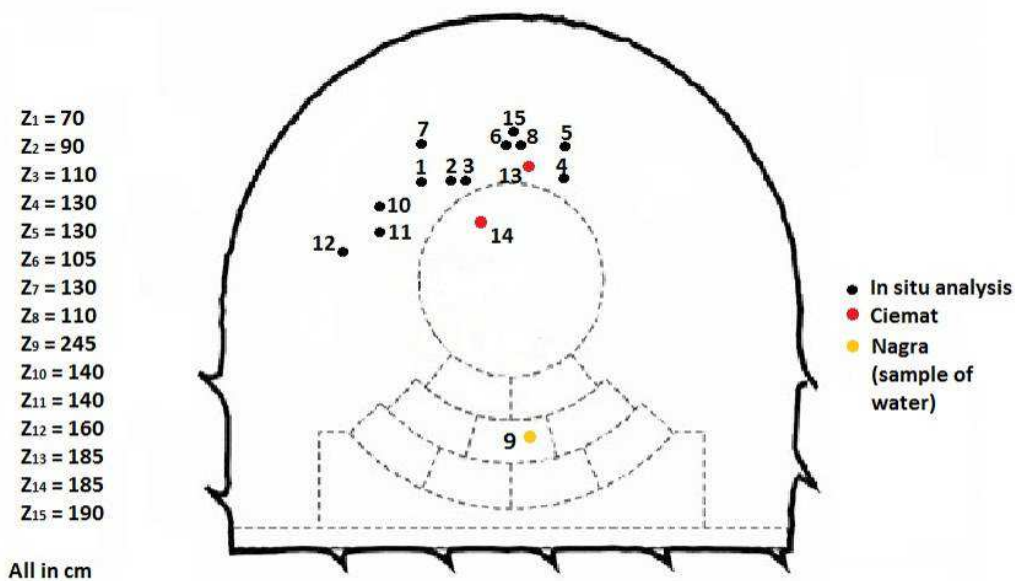
Figure 46 shows the location of the samples and the recipient organizations. It also shows some samples of concrete that were taken for water content on site analysis.

Figure 46: Plug section. Samples

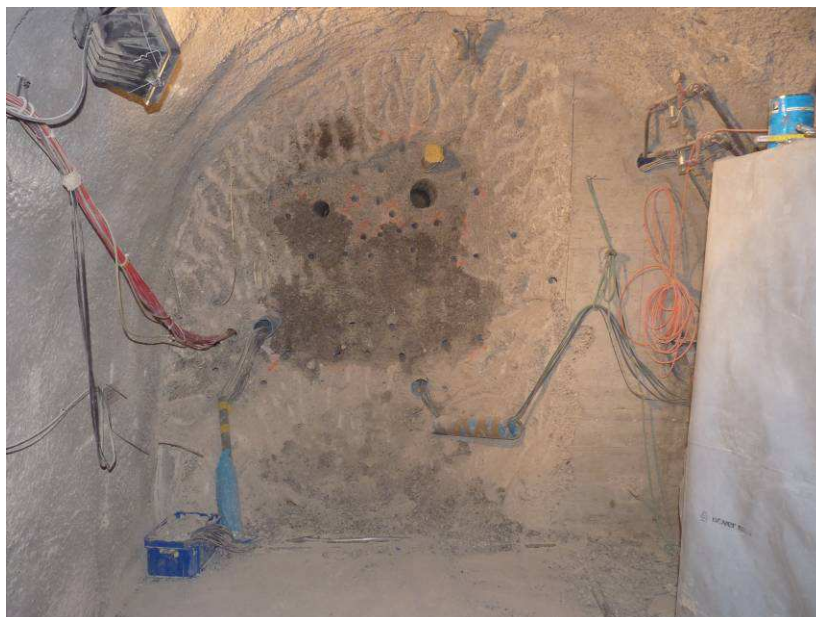
Wet areas were observed while breaking the concrete (See Figure 47).

Figure 47: Wet concrete. Plug

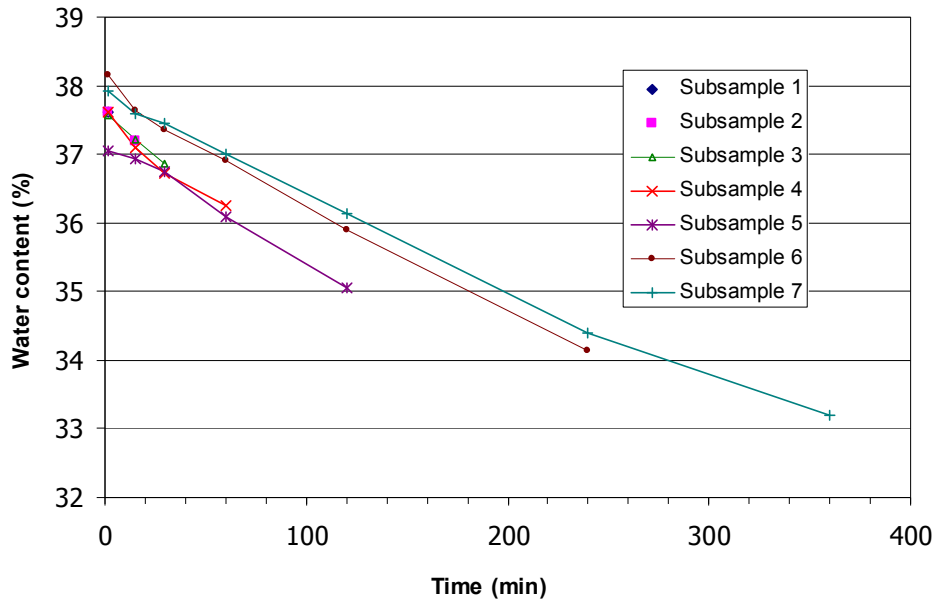
Figure 57: Evolution of the water content in the samples at air conditions in the on site laboratory

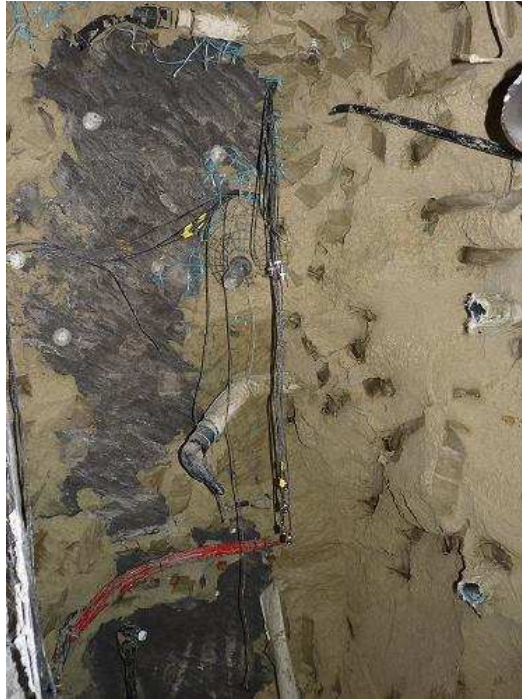
In general, the aspect of the GBM was homogeneous and consistent along the whole operation. No risk of collapse was observed. This same observation can be applied to the Opalinus clay as it seemed to have kept all its physical properties intact. See Figure 68.

Figure 68: OPA after the dismantling operation

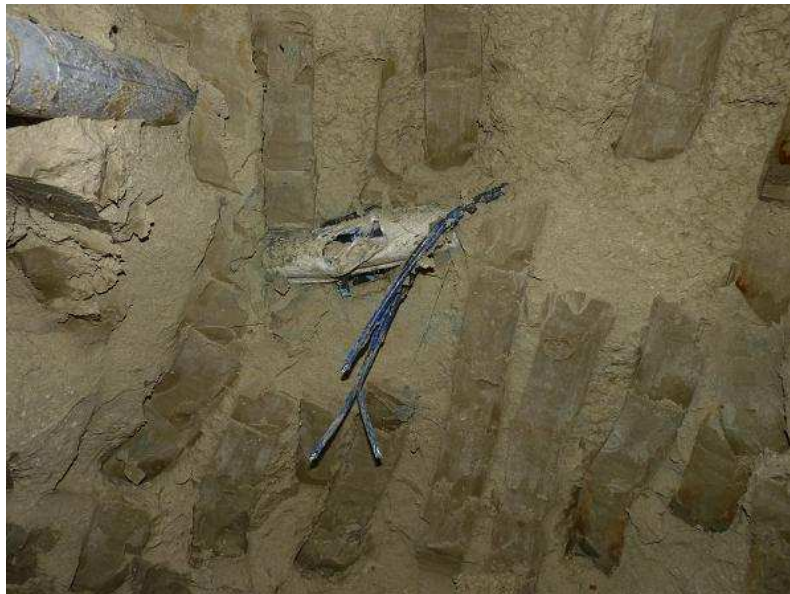
The rest of elements of the experiment such as hydration pipes, cables, geotextile...all of them were in perfect conditions. If any cable was damaged, it was during the bentonite removal operation as it was no possible to exactly predict the location of them after the swelling of the bentonite due to the hydration. The tools used to remove the bentonite were powerful and sharp and by the time the cables were reached, sometimes it was already too late to save them. See Figure 69.

Figure 69: Broken cables during the bentonite removal

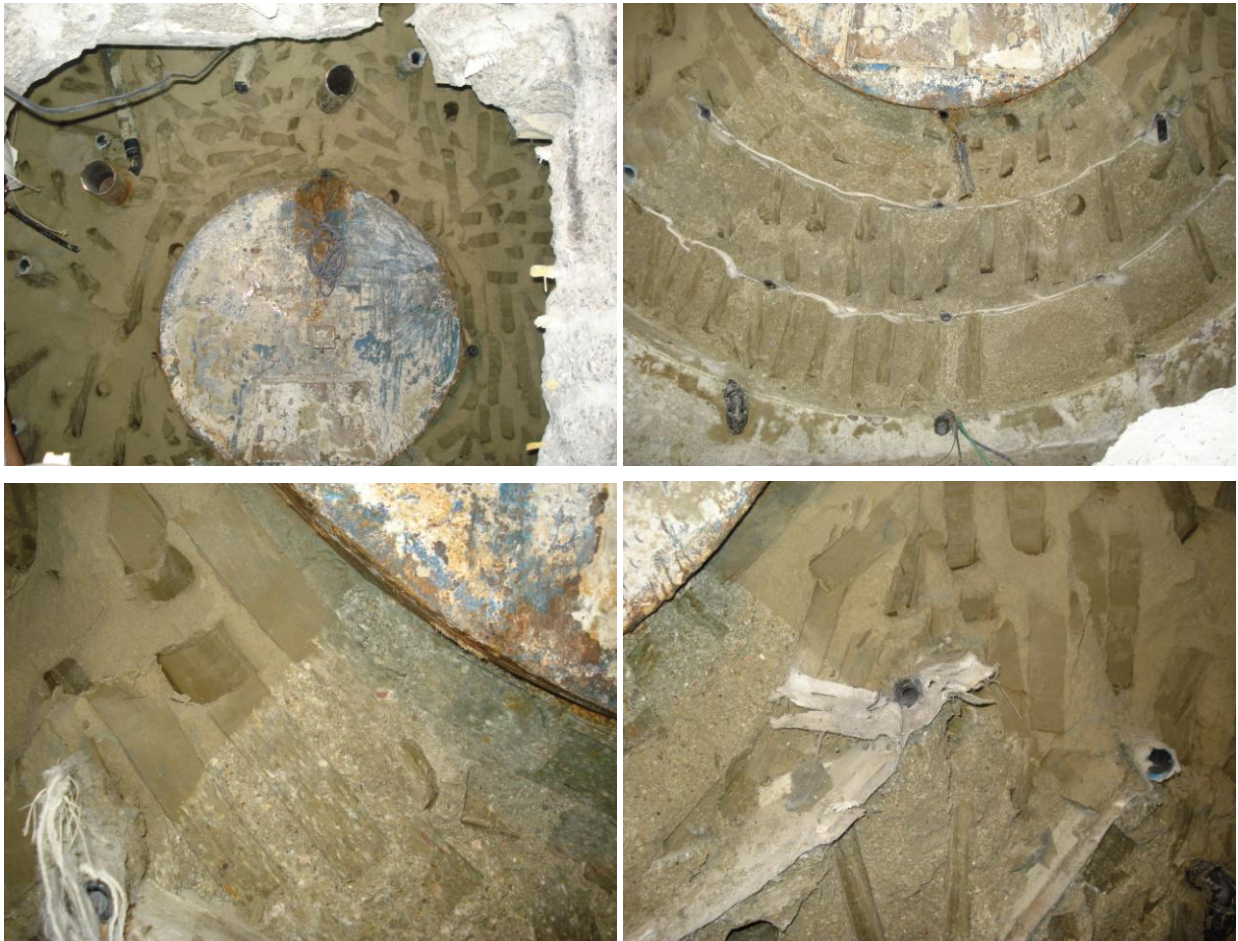
Figure 3: Appearance of the GBM (left up), the bentonite blocks (right up), and the GBM-blocks contact (bottom) upon dismantling.

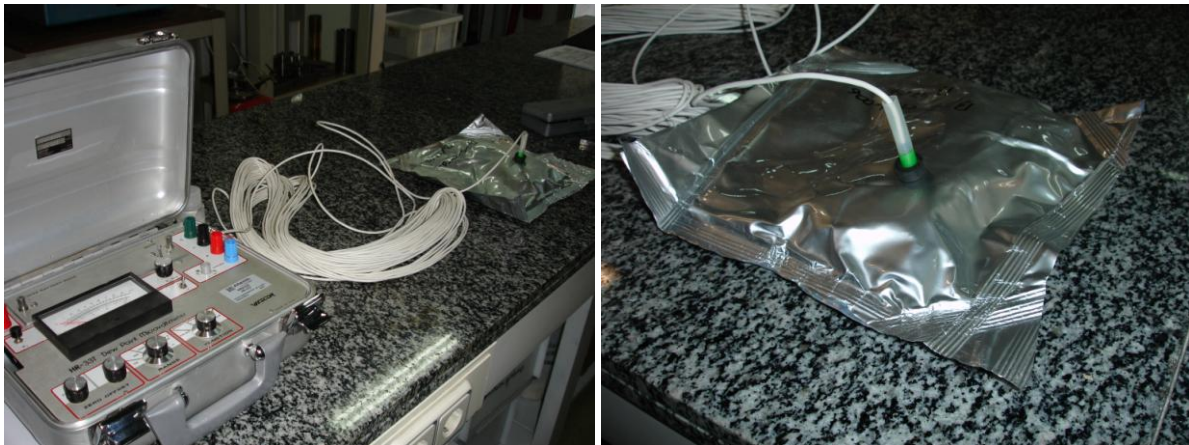
Figure 11: Measurement of relative humidity and temperature with psychrometers
