Long-term Performance of Engineered Barrier Systems PEBS

Report on GAME status, 2nd period

GAME data analysis report before dismantling

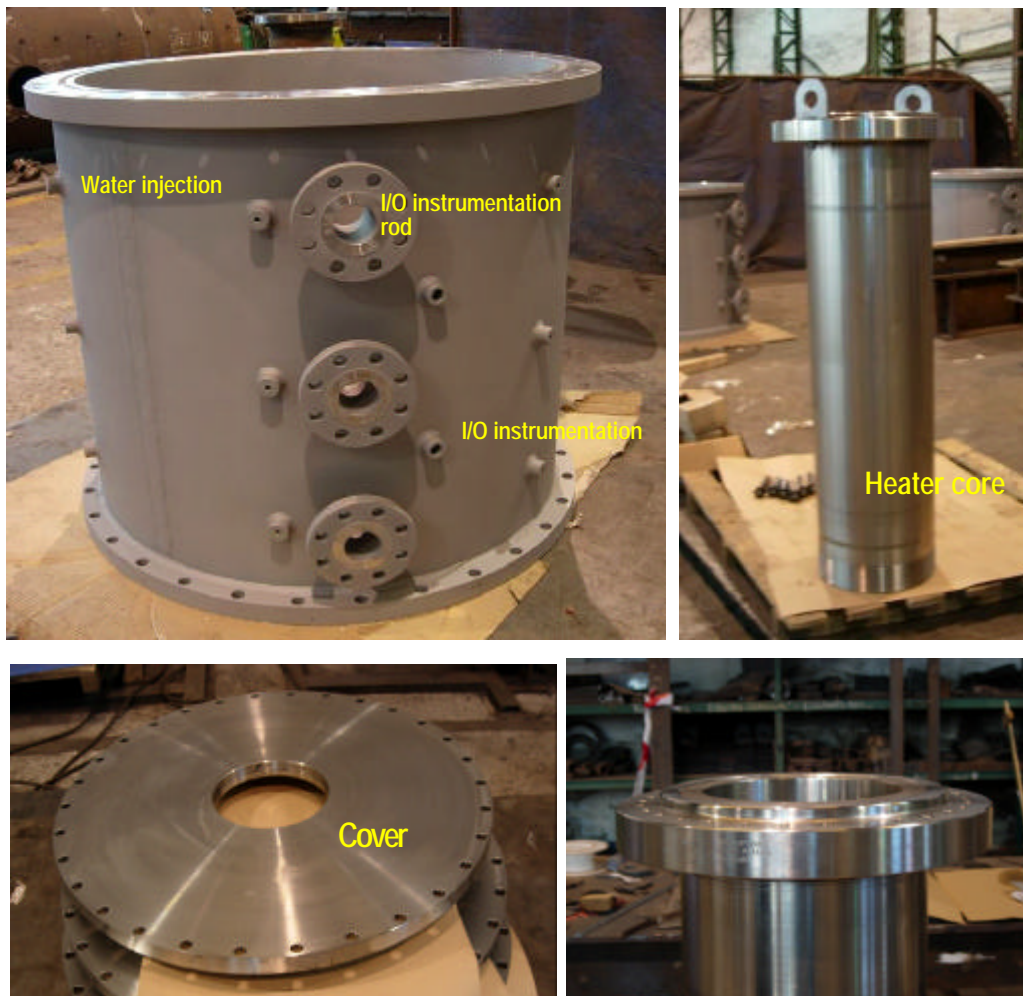
The external cylinder of the confining structure is perforated in 29 points: 5 large-diameter I/Os for insertion of the instrumentation rods, 6 medium-diameter I/Os for the exit of sensor cables, and 18 small-diameter I/Os for water injection (Figure 2-1)

Figure 2-1: Main parts of the structure: external cylinder, heater core,annular cover and heater flange.

Two concentric cylindrical bodies, closed with two annular covers, compose the confining structure, completely made of SS316L. The whole set was placed on a mobile metallic bed.

Inner diameter	0.94m
Inner length	1.00 m
Wall thickness	0.05 m
Design pressure	5 MPa
Total empty mass (estimated)	5280 kg

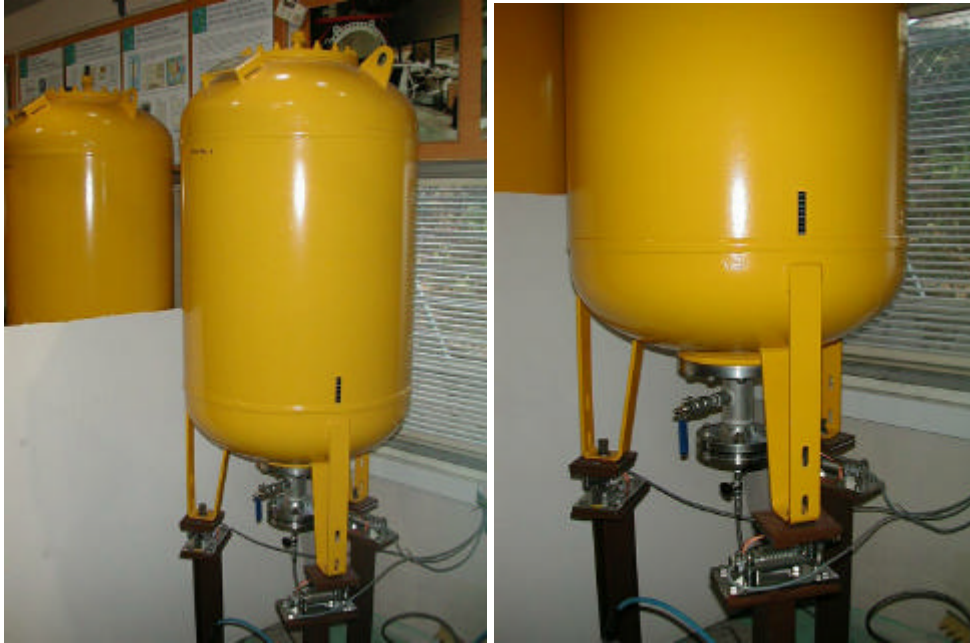
The system consists of a tank with a total capacity of approximately 0.3 m³ that supplies water through a network of pipes joined to the 18 water injection nozzles in the confining structure. The hydration water is pressurized through N₂ gas, at a constant and controlled pressure. Each tank is supported on three metallic legs, where three load cells let us weight the loss of mass, which corresponds to the injected water. (Figure 2-2). Using the values from the weighting system and the nitrogen pressure of the hydration tanks, the injected water mass is determined and registered in the DAS.

Figure 2-2: Hydration system: accumulator vessel and detail of the load cells.

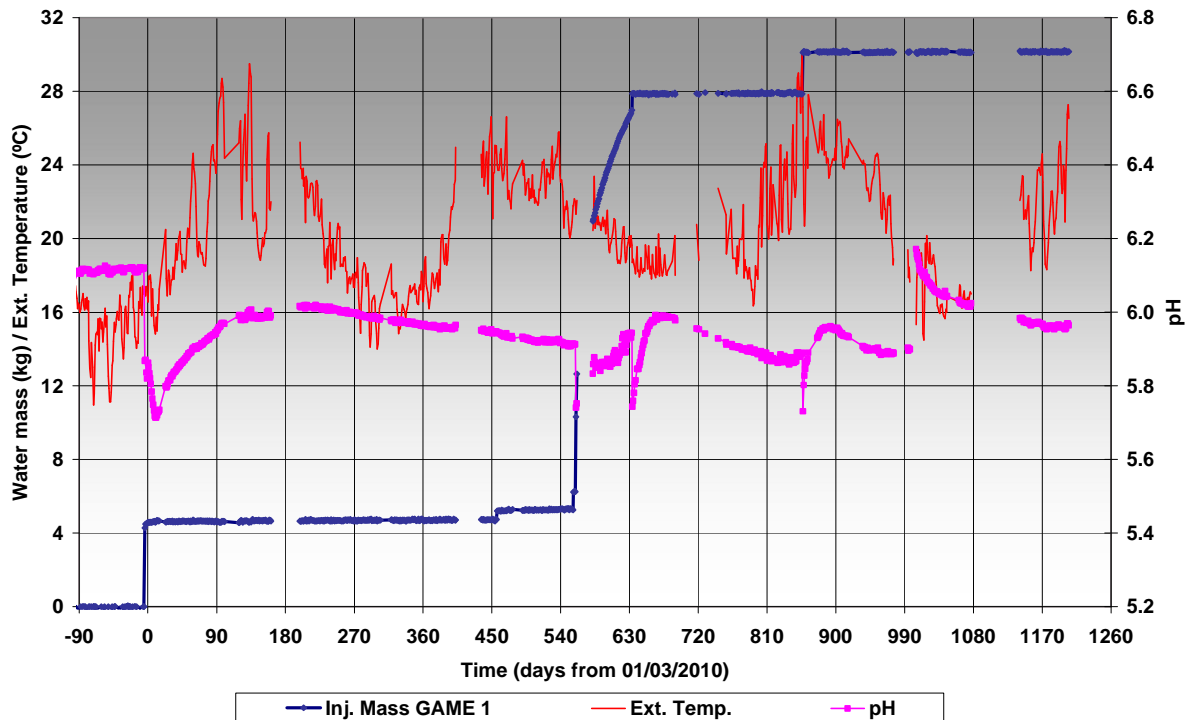
From this time up to the beginning of the PEBS project a total amount of 99.6 kg of water was injected in the test. This value is our zero mass reference at 23/02/10 (day -7; Figure 3-1).

Figure 3-1: Test S1 hydration: injected water, pH and temperature.

After the major modifications (turning of the structure and changes in the instrumentation ports), other injections were made from June 11' to October 11' but slight leakages have also been observed (Table 3.1; Figure 3-1, increasing mass up to day 630). From November 11' to July 12', a new sealing system was implemented in the head of the sensors while the hydration was stopped. In July 12', a new injection was performed but slight leakages were detected in the sensors. From this date, corresponding to an increase in the target

No major variations were observed during injections in the temperature but the pH values seem to be related with the water movement in the hydration line (first movement produced a sharp decreasing, days 0, 560, 633 and 857, to be re-equilibrated). A sharp increasing (0.2 pH units) is observed at day 1005, without explanation. Values observed are in the range of those in the previous project.

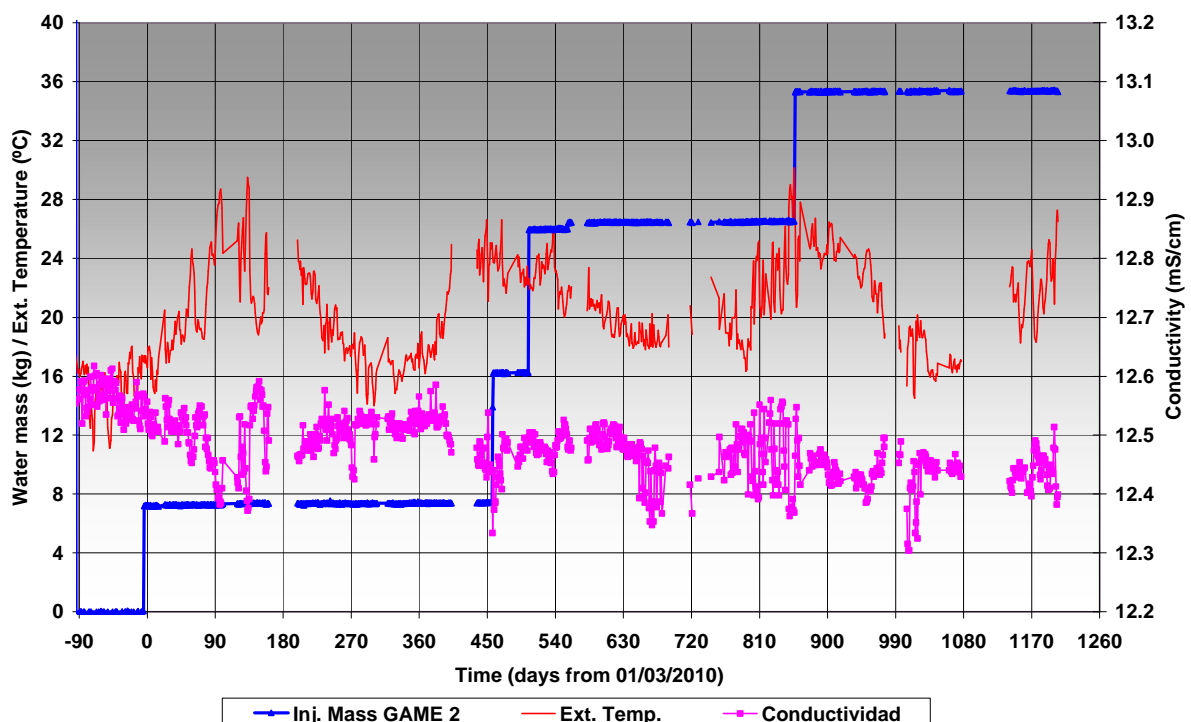
As in the S1 test, from the first flooding up to the beginning of this project a total amount of 91.5 kg of water was injected in the test. This value corresponds to our zero mass reference at 23/02/10 (day -7; Figure 3-2).

Figure 3-2: Test S2 hydration: injected water, EC and temperature.

After the major modifications, new injections were made from June 11' to September 11' but massive leakages were observed (related to the steps, Table 3.2; Figure 3-2). From November 11' to July 12', the new sealing system was implemented as in S1 test. In July 12', the new injection was performed but major leakages were detected in the rods. From this date, corresponding to the increase in the target temperature of the heaters, the hydration was stopped but, as in the S1 test, the injection water in the structure was not purged to sustain a passive water intake of the barrier.

Conductivity values seem to follow a seasonal wave to be confirmed, but not affected during injections. Values observed are in the range of those in the previous phase.

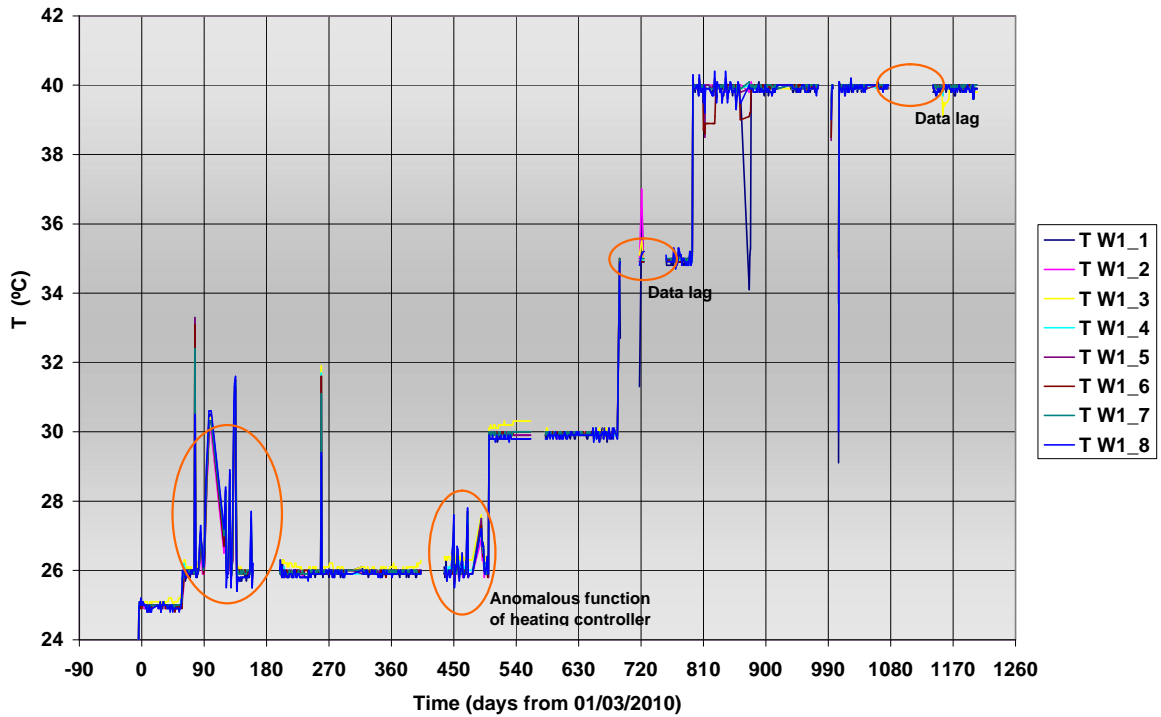
Two types of behaviour have been observed in both experiments. First, some period of apparent anomalous function of the heaters (Figure 3-3 and Figure 3-5) can be attributed to external temperatures so high that induce heater temperatures higher than the target ones, Second, the lose of data transmission has not affected the operation of the heating control (Figure 3-4 and Figure 3-6).

Figure 3-3: Heater temperatures from the controller: test S1

Figure 3-5: Heater temperatures from the controller: test S2

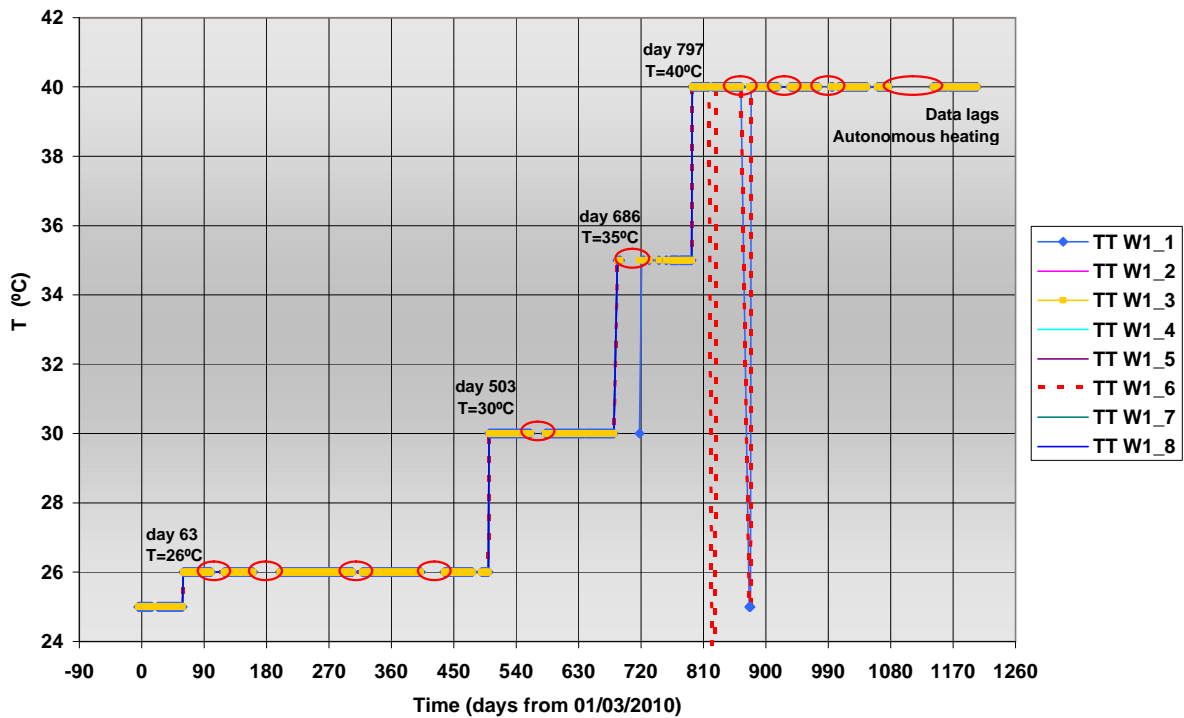
Figure 3-4: Target temperatures from the controller: test S1

Figure 3-6: Target temperatures from the controller: test S2.

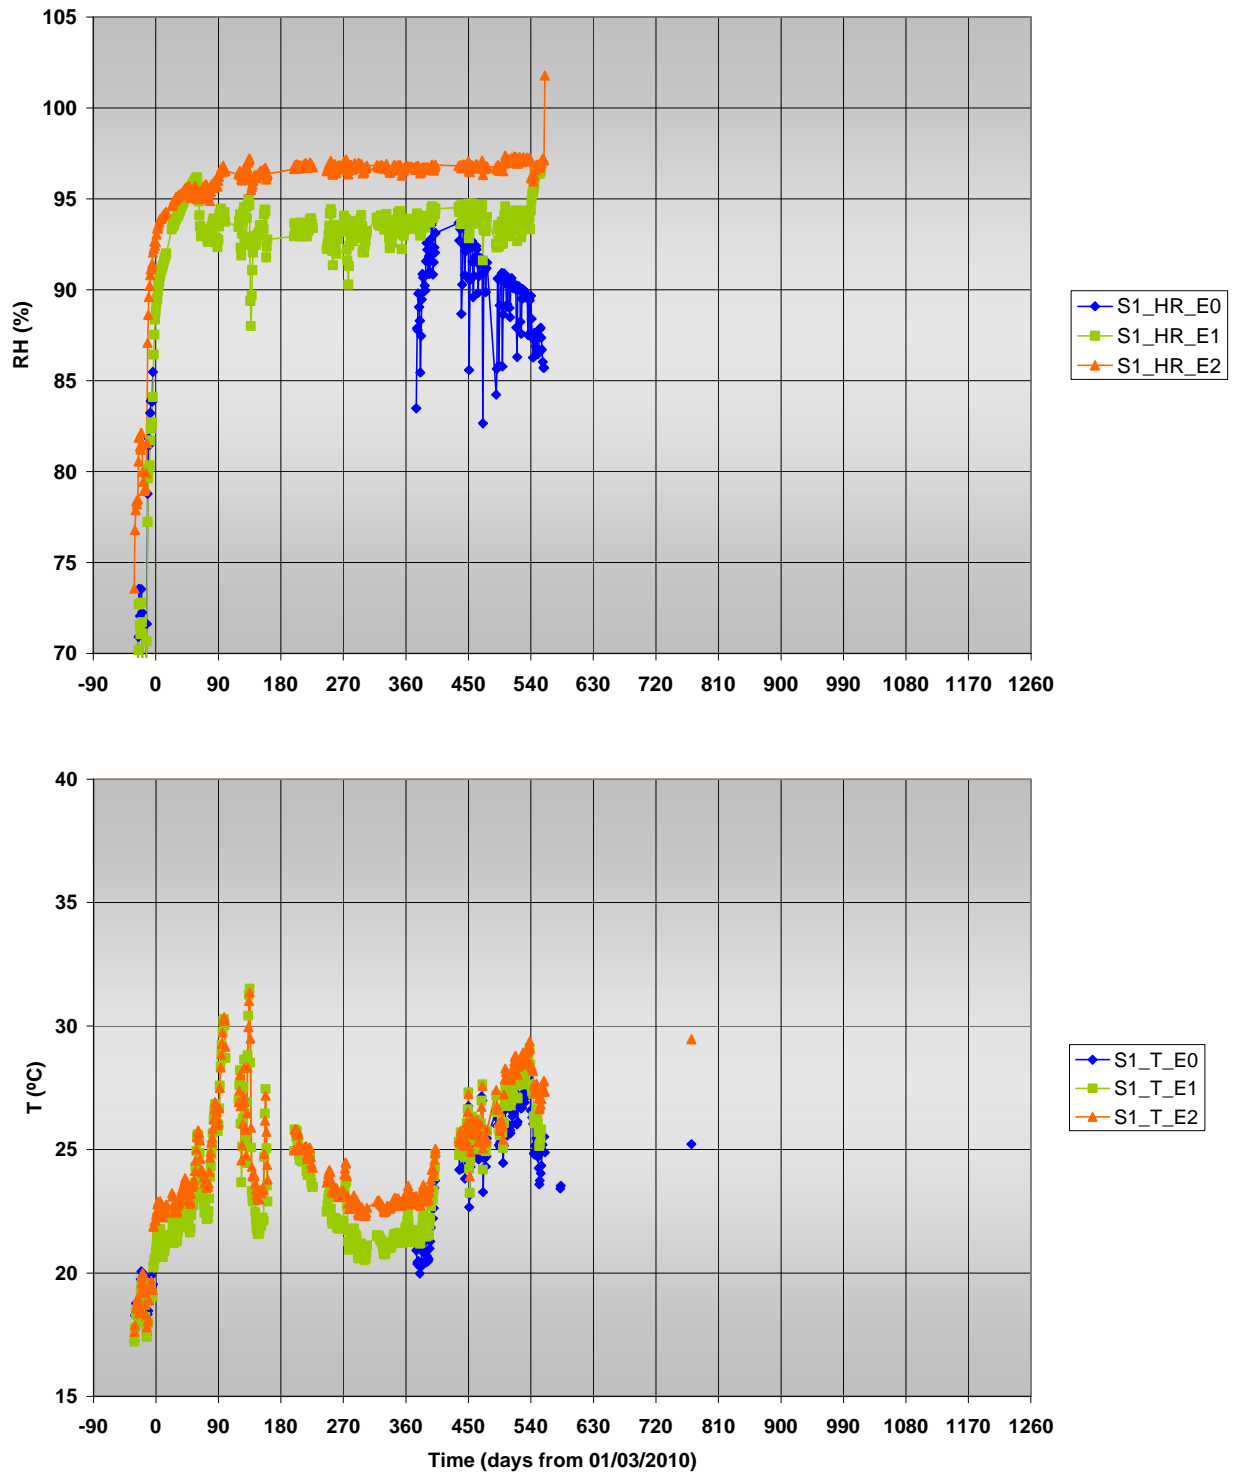
From Figure 3-7 to Figure 3-14, it is clear that the damage of the sensors is smaller in test S1 again. Three sensors were replaced before the water injection around day 450: A1, D2 and E0. Two of them were damaged again after the water injection around day 550.

Figure 3-7: Test S1 PEBS phase: RH and T values from rod A: sensors A0, A1, A2 located at coordinates (X= - 0.3; Y= 0.395, 0.315, 0.225, respectively)

Figure 3-8: Test S1 PEBS phase: RH and T values from rod B: sensors B0, B1, B2 located at coordinates (X= 0.0; Y= 0.405, 0.295, 0.205, respectively)

Figure 3-9: Test S1 PEBS phase: RH and T values from rod C: sensors C0, C1, C2 located at coordinates (X= 0.3; Y= 0.425, 0.335, 0.245, respectively)

Figure 3-10: Test S1 PEBS phase: RH and T values from rod D: sensors D0, D1, D2 located at coordinates (X= -0.15; Y= 0.445, 0.355, 0.265, respectively)

Figure 3-11: Test S1 PEBS phase: RH and T values from rod E: sensors E0, E1, E2 located at coordinates (X= 0.3; Y= 0.465, 0.375, 0.285, respectively)

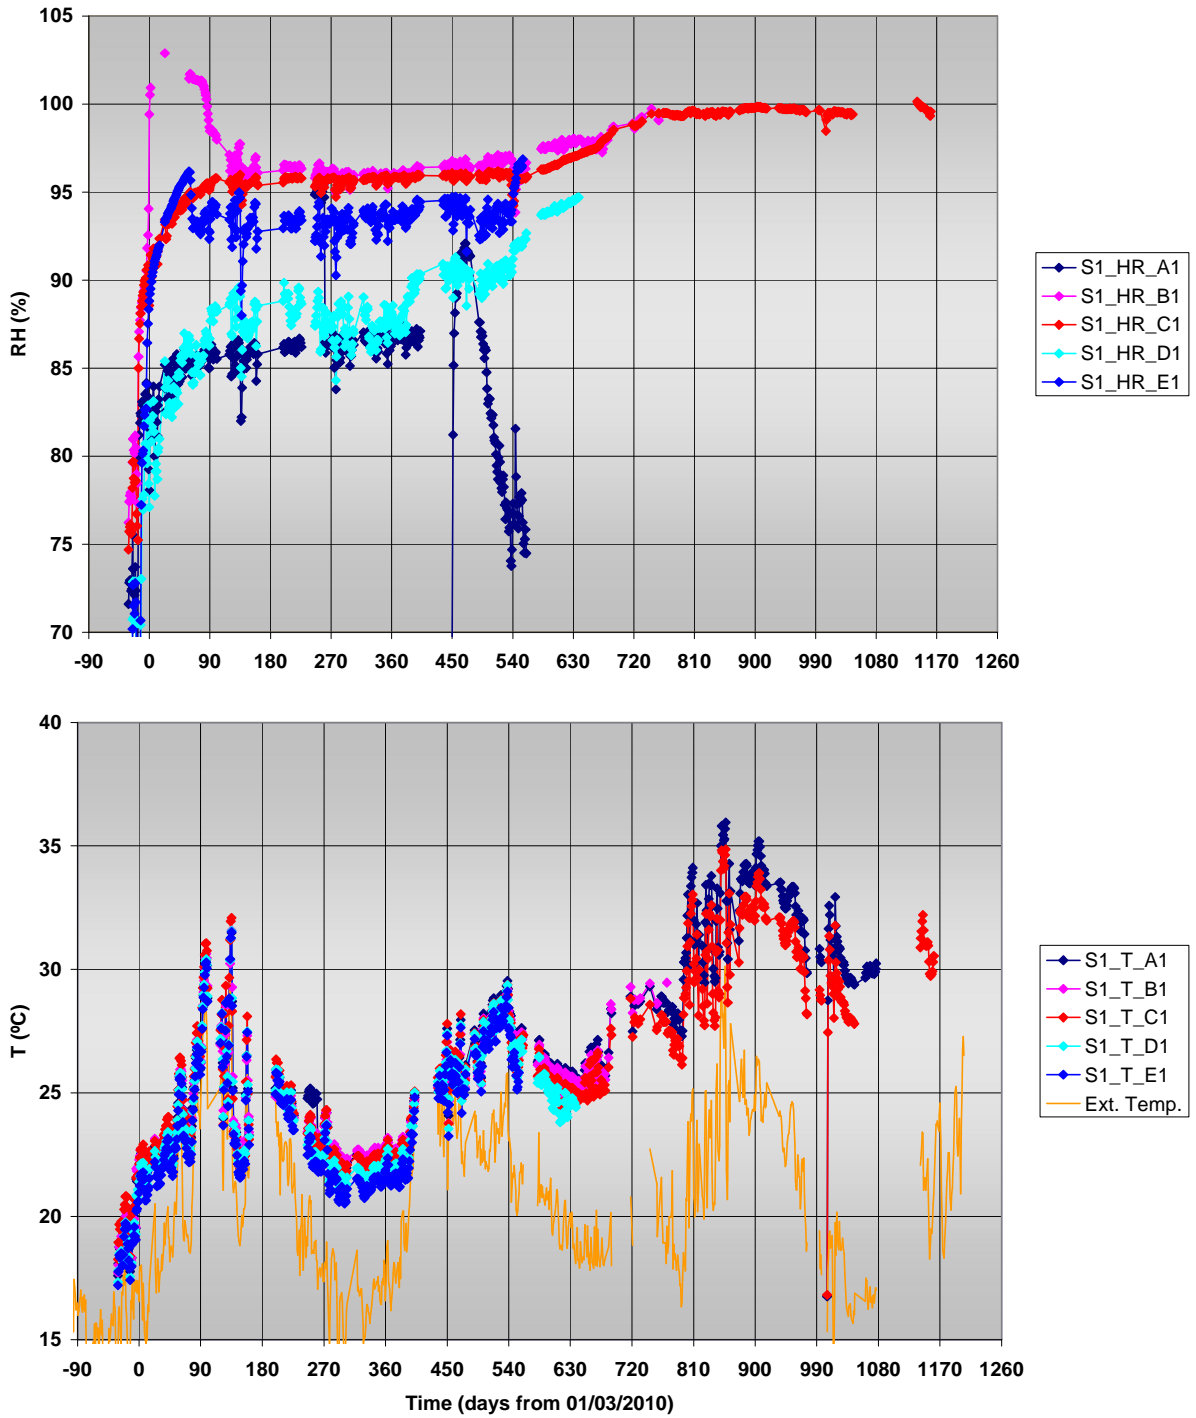
If the sensors are grouped by distance to heater surface (three groups: outer, intermediate and inner; Figure 3-12 to Figure 3-14, respectively), it can be observed that the values of the inner positions (level 2, Figure 3-14) are more homogeneous. The external temperature is also shown for comparison.

The temperature figures (bottom pictures in the above range) show a yearly seasonal tendency over the small waves observed (in Figure 3-12 to Figure 3-14). The expected behaviour, as described in the previous phase, is observed in all the rods and level, but is clearer in the longer rods and during the colder phase of the thermal waves. During the hotter phases, the differences between levels decrease.

Figure 3-12: Test S1 PEBS phase: RH and T values from outer levels: (X, Y) location: A0(-0.3, 0.245), B0(0.0, 0.255), C0(0.3,0.275), D0(-0.15, 0.295), E0(0.15, 0.315)

Figure 3-13: Test S1 PEBS phase: RH and T values from intermediate levels: (X, Y) location: A1(-0.3, 0.165), B1(0.0, 0.145), C1(0.3, 0.185), D1(-0.15, 0.205), E0(0.15, 0.225)

Figure 3-14: Test S1 PEBS phase: RH and T values from inner levels: (X, Y) location: A2(-0.3, 0.075), B2(0.0, 0.055), C2(0.3, 0.095), D2(-0.15, 0.115), E2(0.15, 0.135)

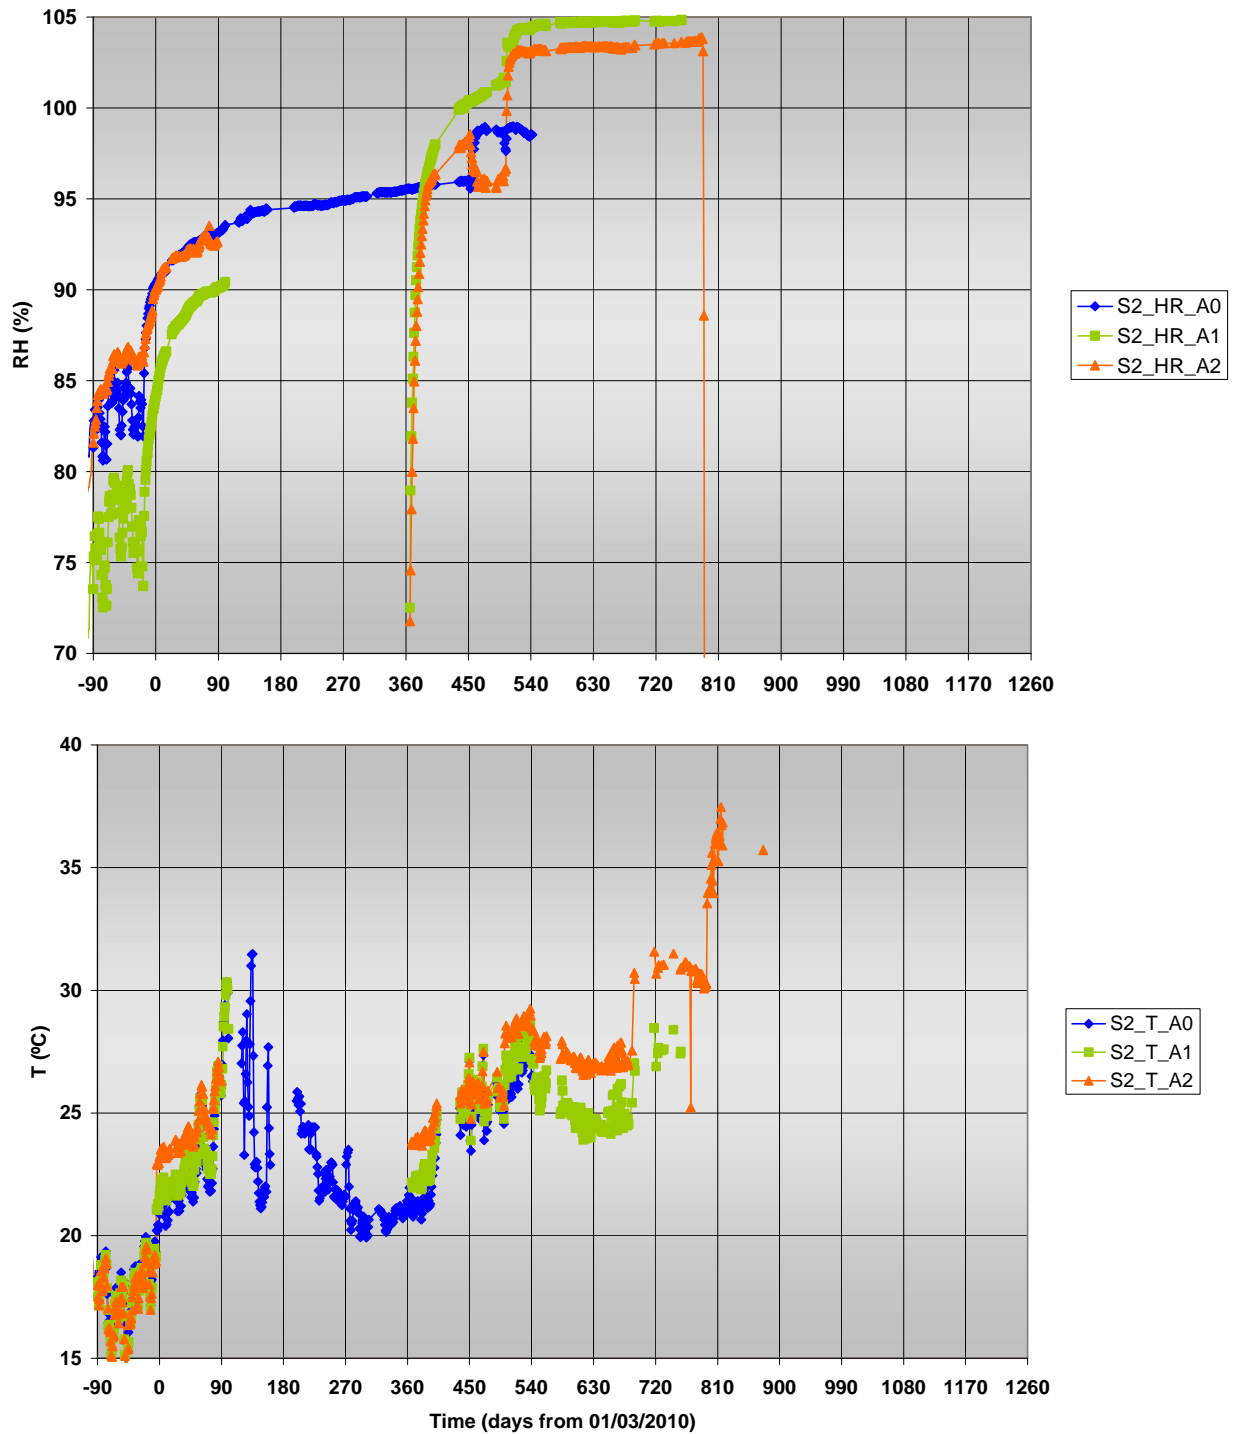
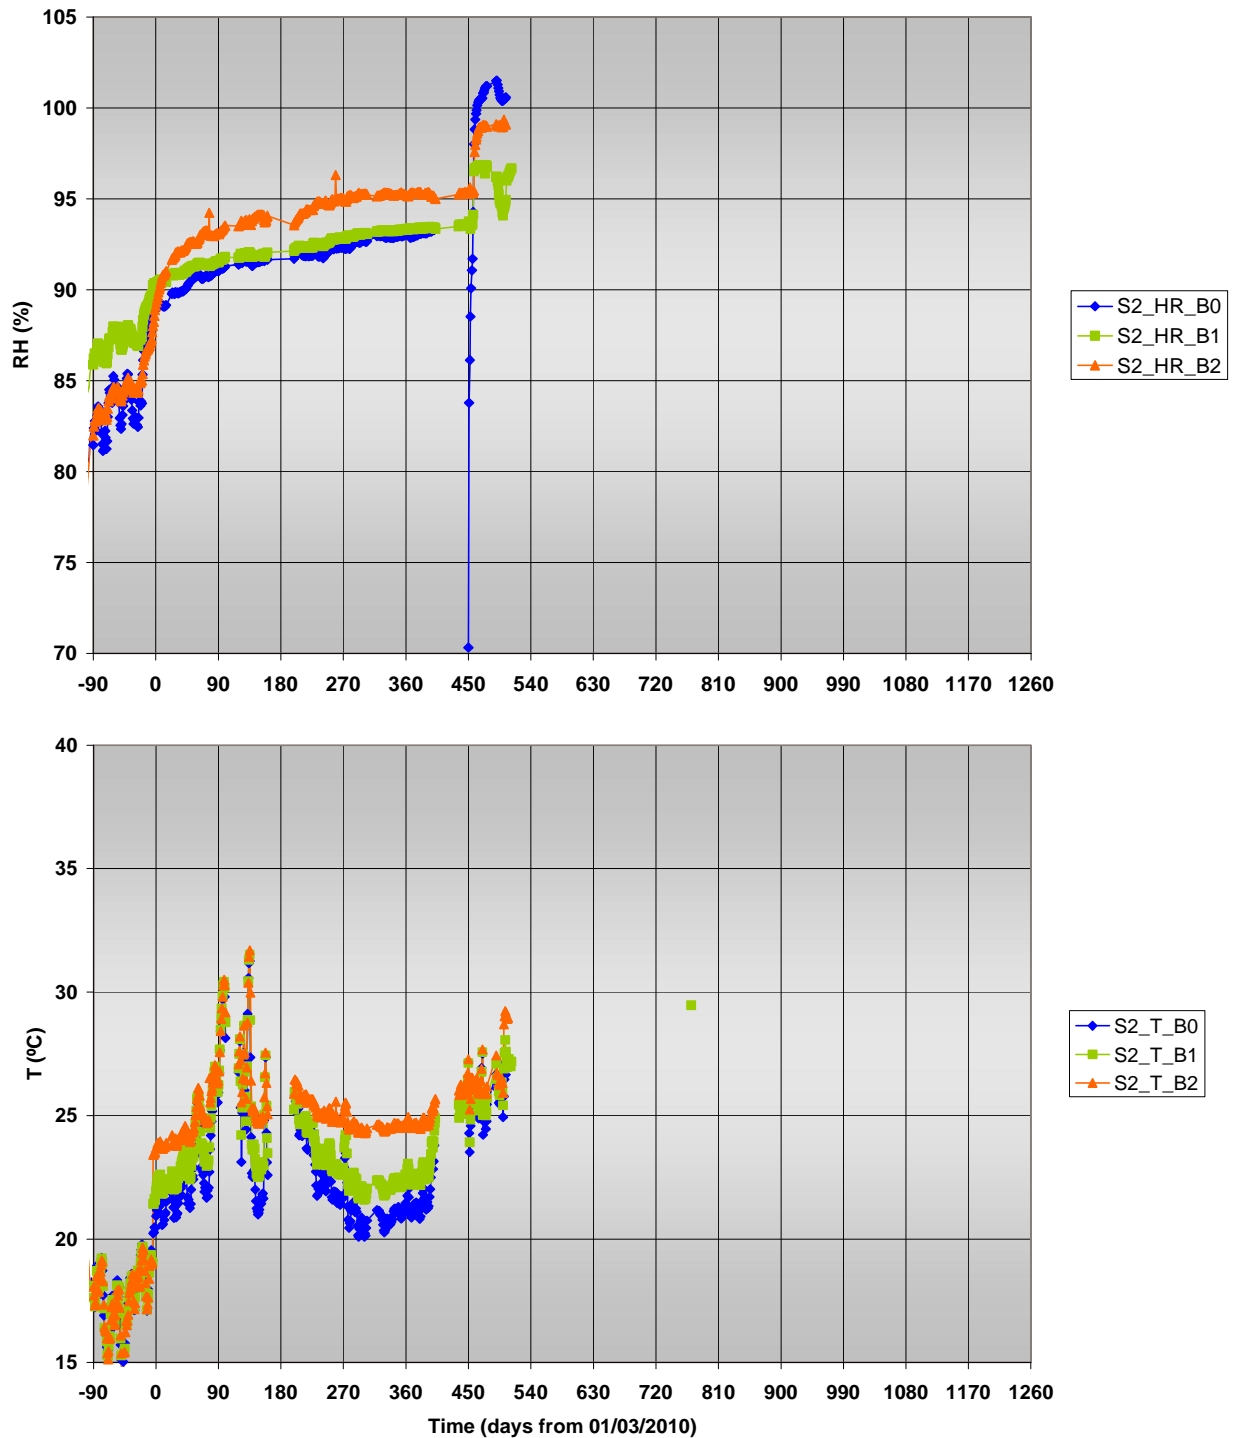
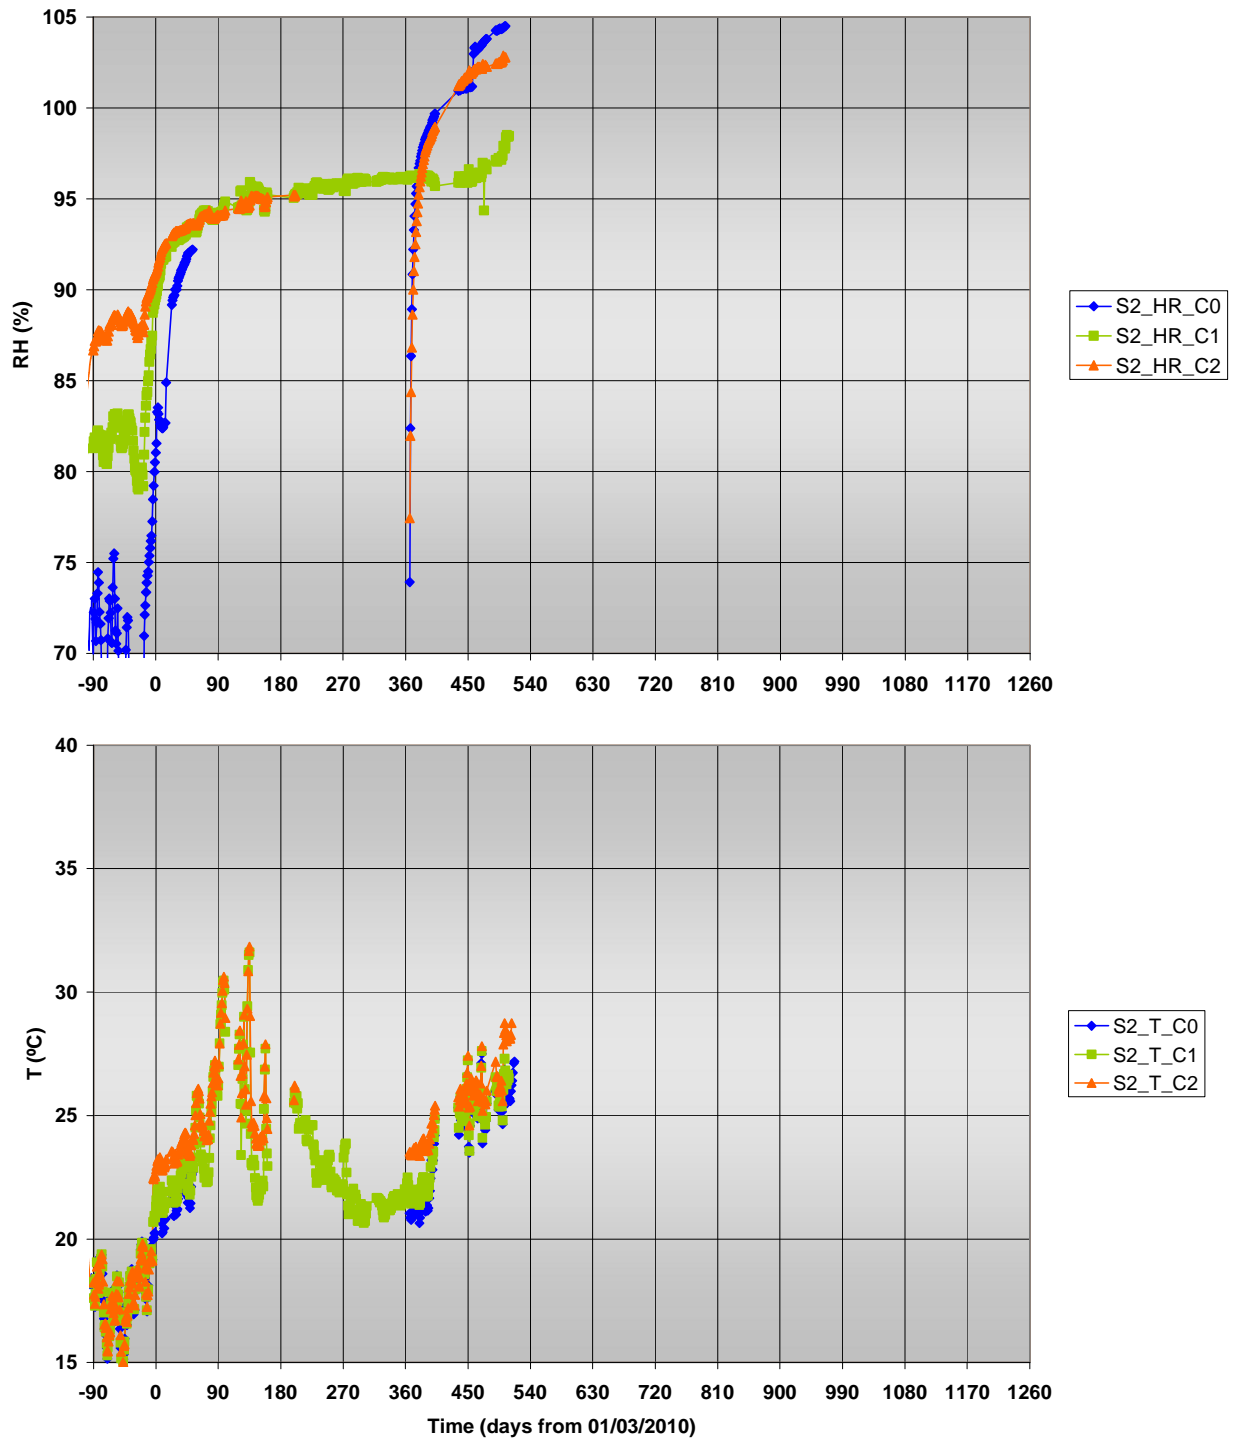
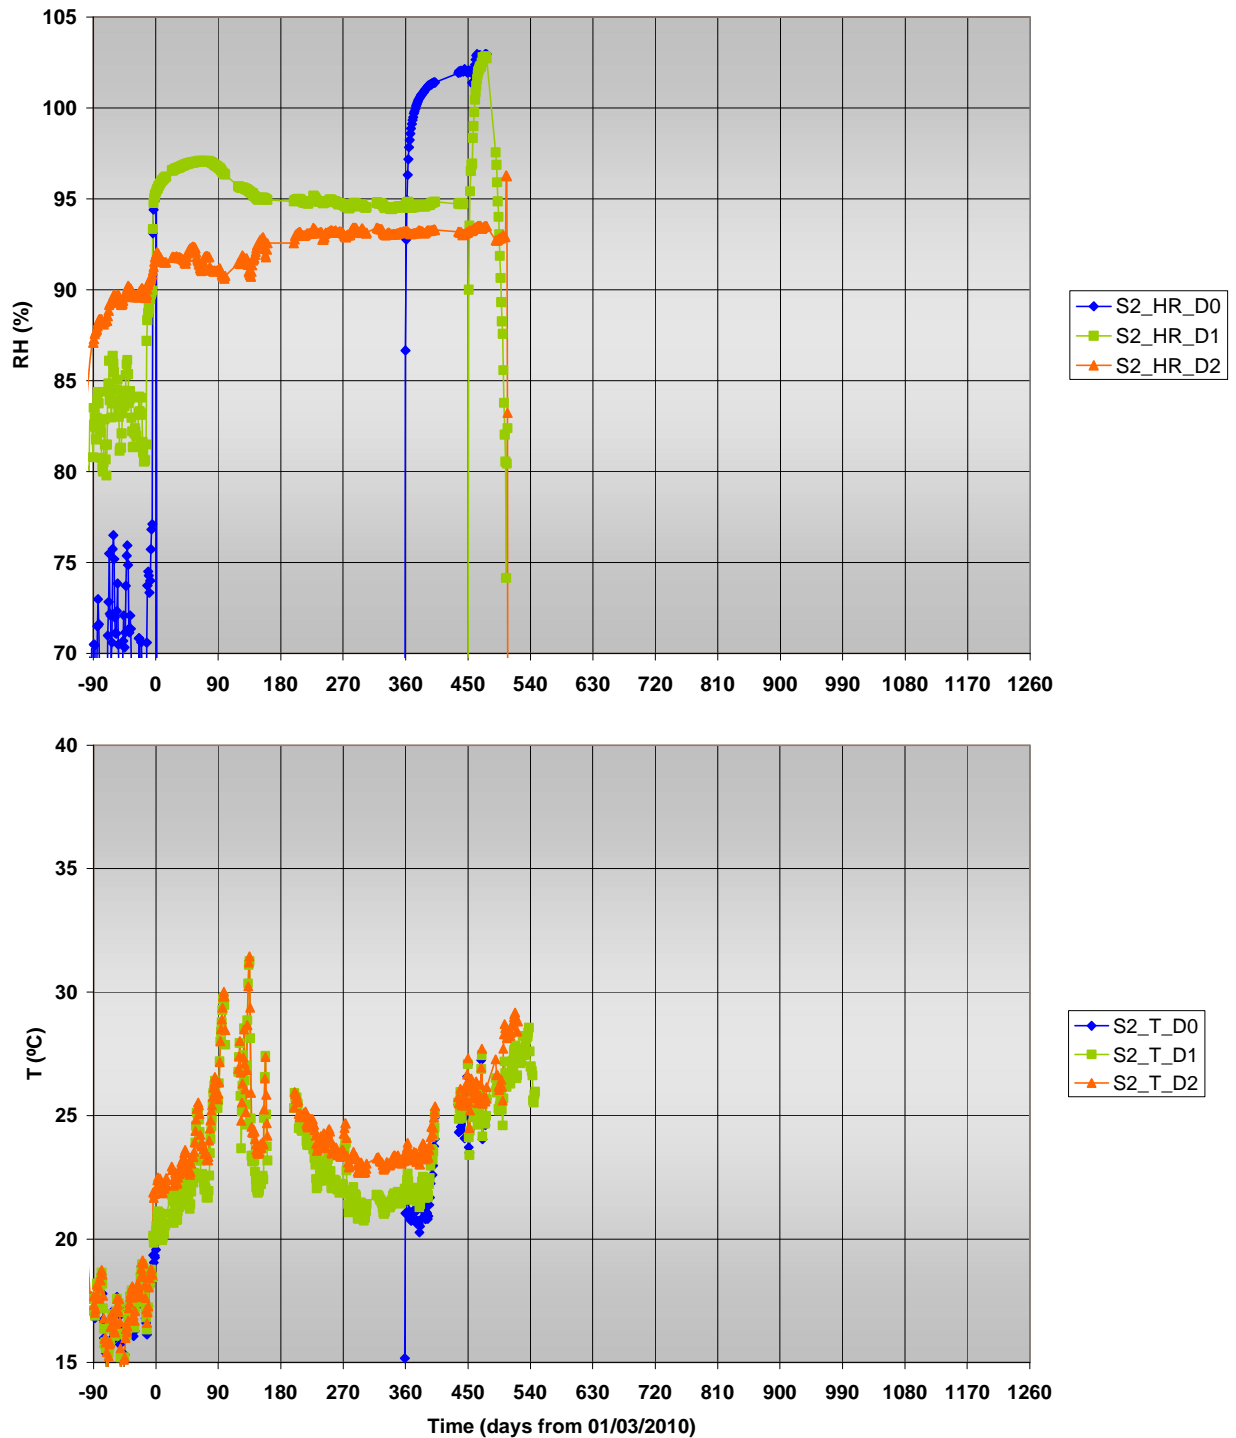
From Figure 3-15 to Figure 3-22, it is clear that the damage of the sensor is greater in test S2. Almost all sensors have been replaced, some of them even twice, before they could be considered as flooded by the saline water. In other cases, the sensors were operating during long time in oversaturated conditions.

Figure 3-15: Test S2 PEBS phase: RH and T values from rod A: sensors A0, A1, A2 located at coordinates (X= -0.3; Y= 0.395, 0.315, 0.225, respectively)

Figure 3-16: Test S2 PEBS phase: RH and T values from rod B: sensors B0, B1, B2 located at coordinates (X= 0.0; Y= 0.405, 0.295, 0.205, respectively)

Figure 3-17: Test S2 PEBS phase: RH and T values from rod C: sensors C0, C1, C2 located at coordinates (X= 0.3; Y= 0.425, 0.335, 0.245, respectively)

Figure 3-18: Test S2 PEBS phase: RH and T values from rod D: sensors D0, D1, D2 located at coordinates (X= -0.15; Y= 0.445, 0.355, 0.265, respectively)

Figure 3-19: Test S2 PEBS phase: RH and T values from rod E: sensors E0, E1, E2 located at coordinates (X= 0.3; Y= 0.465, 0.375, 0.285, respectively)

Some sensors were damaged immediately after the injection around day 450 and, at least, nine sensors, the closest to the hydration surfaces, were damaged during the water injection event on day 505. When the sensors were not damaged, the ones placed close to the hydration surfaces (external level 0, Figure 3-20, and internal level 2, Figure 3-2) registered a RH step associated to the injection events. No sensors remain operative from day 810.

The relation of the damage of sensors to the water injection pulses indicates the possibility of some defect in the installation of the rods or related to the interaction between the concrete blocks and the sampling filters. This could be possible the direct flow of water within the sensors.

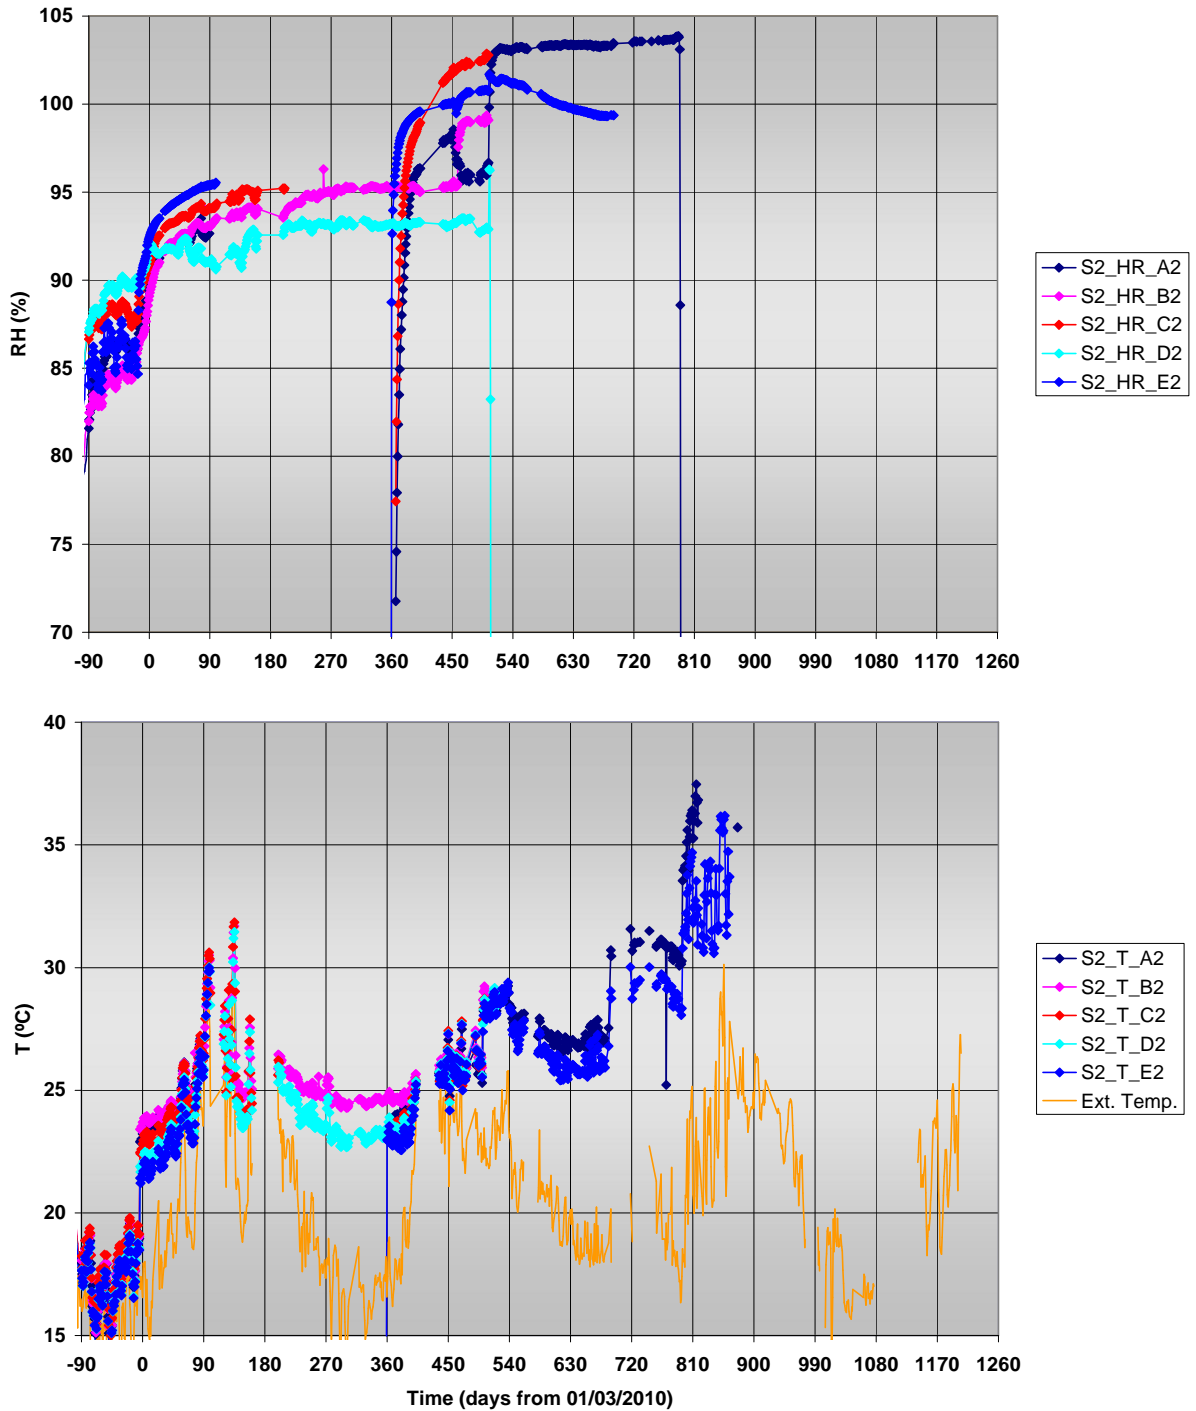
If the sensors are grouped by distance to heater surface (three groups: outer, intermediate and inner; Figure 3-20 to Figure 3-22, respectively), it can be observed that the values of the intermediate levels (Figure 3-21) are more homogeneous. The external temperature is also shown for comparison.

Figure 3-20: Test S2 PEBS phase: RH and T values from outer levels: (X, Y) location: A0(-0.3, 0.245), B0(0.0, 0.255), C0(0.3,0.275), D0(-0.15, 0.295), E0(0.15, 0.315)

Figure 3-21: Test S2 PEBS phase: RH and T values from intermediate levels: (X, Y) location: A1(-0.3, 0.165), B1(0.0, 0.145), C1(0.3, 0.185), D1(-0.15, 0.205), E0(0.15, 0.225)

Figure 3-22: Test S2 PEBS phase: RH and T values from inner levels: (X, Y) location: A2(-0.3, 0.075), B2(0.0, 0.055), C2(0.3, 0.095), D2(-0.15, 0.115), E2(0.15, 0.135)

The temperature figures (even numbers in the above range) show the same yearly seasonal tendency with small waves observed in test S1. This behaviour is observed in all the rods and level, more clearly in the longer rods and during the colder phases of the thermal waves (due to the higher difference between the heater temperature and the room temperature).
